REPORT NO. ANGIAMR3032 PROPUSED MODIFICATIONS TO LIQUID OXYGEN BOIL-OFF VALVE (SERIES D AND E ATLAS MISSILE)

GENERAL DYNAMICS/ASTRONAUTICS November 1961

PROPOSED MODIFICATIONS TO LIQUID OXYGEN BOIL-OFF VALVE (SERIES D AND E ATLAS MISSILE)

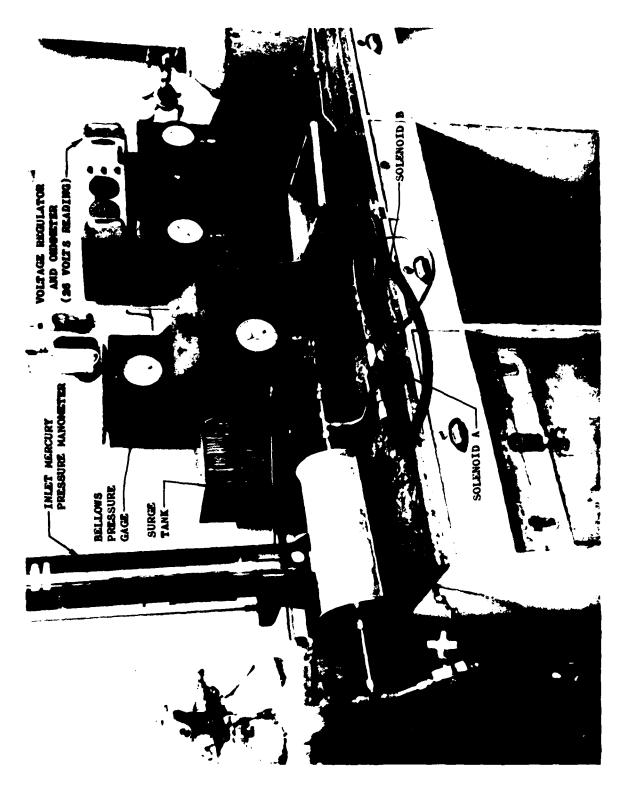
STATIC CYCLING TEST APPARATUS SOLENOID "A" AND "B" ARE ENERGIZED (NO INLET PRESSURE) FIGURE NO. 2

- (a) After heating the Boil-off valve assembly the solenoids required 25 to 30 volts for actuation. This did not meet the specification which requires the solenoids actuate with a minimum of 24 volts.
- (b) The valve performed within specification during the cooling stage of the test. The solenoids required less voltage and the plungers showed less wear than during the heating portion of the test. The leakage measured during this test increased as new sets of plungers were installed. This increase in leakage had no relation to the plating of the plunger but was caused by increasing wear on the poppet seat.

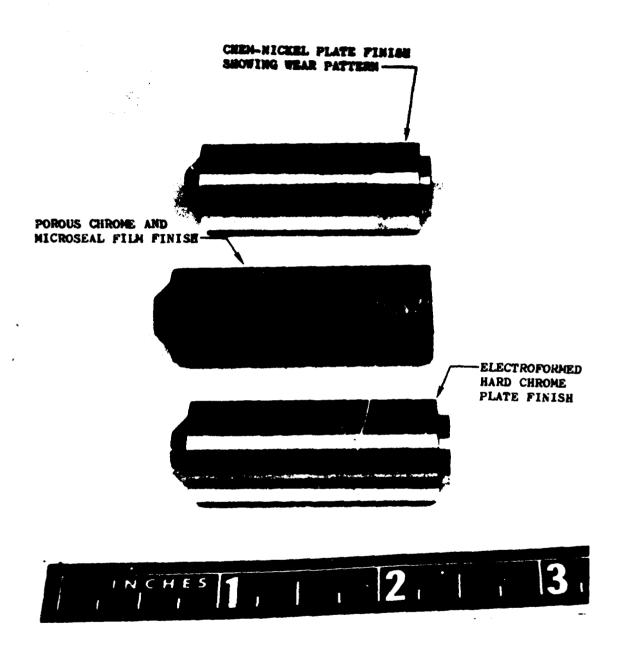
FIGURE NO. 7 LIQUID OXYGEN BOIL-OFF VALVE PLUNGERS

(e) All sets of plungers after being cycled 90 times showed signs of wear at the locking surfaces, but not enough to be considered damaging.

- (c) During the static lift test the solenoids lifted the one pound weight (see Fig. 6) but failed to lift the five pound weight over the required distance of poppet travel. The solenoid lifted the five pound weight when the poppet travel was shortened. This portion of the test showed that solenoid "A" was barely meeting the specification requirements.
- (d) The examination of the plungers showed electroformed hard chrome to be the best metal finish for resisting wear, (see Fig. 7). Teflon finish was next best although showing signs of pealing.
- (e) The plunger with porous chrome plating plus dry lubricant film showed the dry film lubricant wore off at the bearing surface. The plunger with a chem-nickel plated finish showed signs of wear.
- (f) All sets of plungers, after being cycled 90 times, showed sign of wear at the locking surfaces but not enough to be considered damaging.

- 1. The entire surface of the plunger including the ends should be electroformed with hard chrome and coated with Microseal dry film lubricant per GD/A Spec. No. 0-75045.
- The solenoid "A" should operate at 28 volts instead of 24 volts as per \*EOP 310.10.
